Manhole Inspection Summary

Manhole # S55K__020MH

Insp Date: **5/30/08 9:41 AM**

Location Address: **3719 foster**

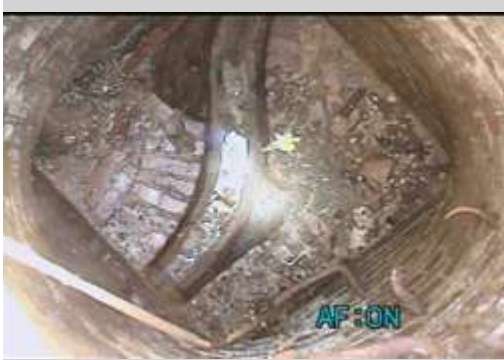
Miscellaneous

debris

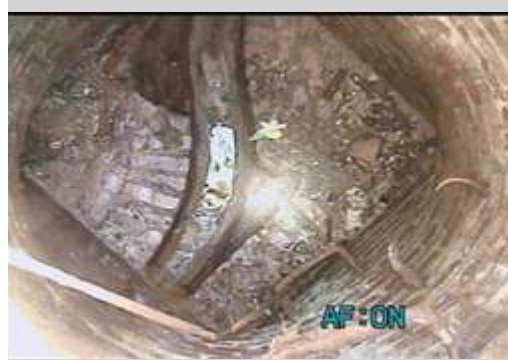
Defect 2

Steps Count: **3** Missing: **1** ☒ Corroded

steps

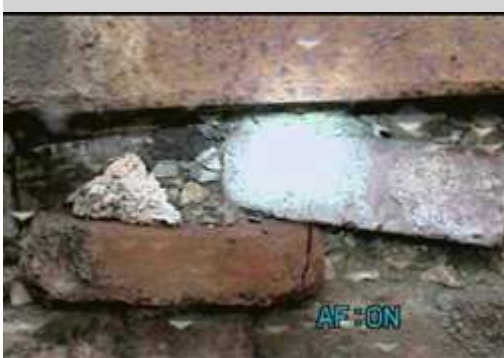
Defect 1

Condition: ☐ Sound ☐ Cracked ☐ Root Intrusion ☒ Loose Brick ☒ Deteriorated

chimney loose bricks, deteriorated

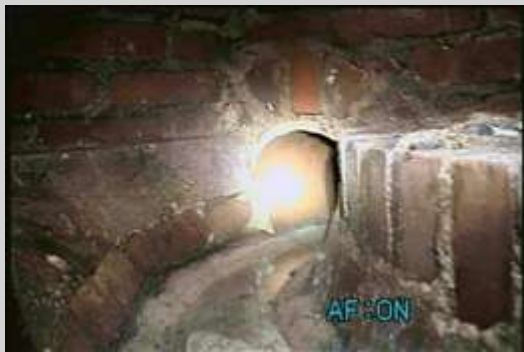
12 O'Clock Outflow

8 in. Circular Gravity Sewer
Pipe Out @ 12 O'Clock

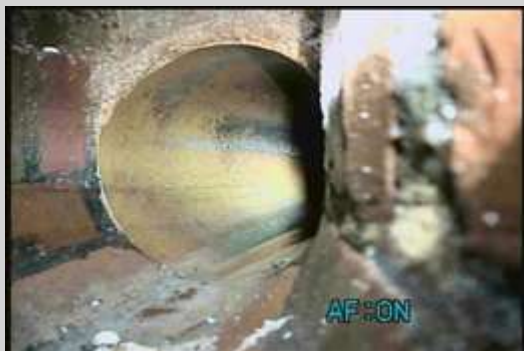
6 O'Clock Inflow

8 in. Circular Gravity Sewer
Pipe In @ 6 O'Clock
